# **DIAMOND DIESEL and TURBOCHARGER SERVICE, Inc.**

## **SEIZURE OF HEAD AND ROTOR ASSEMBLIES**

SERVICE BULLETIN #203 R1

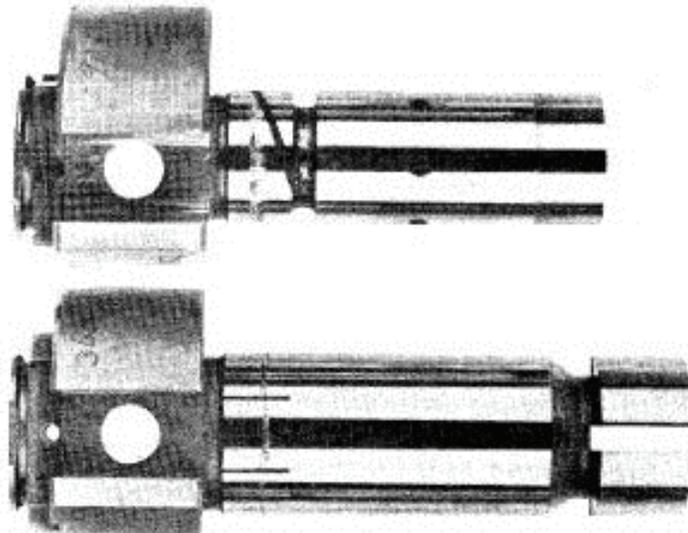
EXAMPLE I - DIRT

**LOCATION:** Dirt can seize any pump type and usually is found at the extremities of either the charging or discharge ports.

**CAUSE:** Large particles of dirt or other foreign matter wedged in rotor - head clearance or in leak-off and lubrication slots.

1. Dirt enters thru improper protection of fuel lines leading from final filter to the injection pump when this line is removed for any reason.
2. Incorrect or missing fuel filter element.
3. Improper cleaning of filter container when replacing.
4. Improper sealing of filter element so dirty fuel bypasses element.
5. Improper protection of fuel inlet to injection pump prior to installation of fuel inlet line.
6. Dirt entering transfer pump during field replacement of transfer pump or end plate parts.

**CAUTION:** Do not assume dirt or foreign material is cause of seizure unless it is visible in the hydraulic head.

**REMEDY:** Clean Fuel!!!

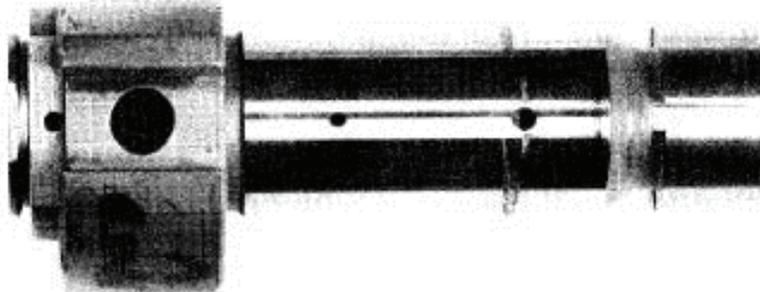
EXAMPLE II - BOTTOMED CONNECTOR SCREW

LOCATION: Directly in line with or adjacent to a discharge port in the head.

CAUSE: Connector screw bottoms in discharge hole in head.

1. One or more connector screw washers missing.
2. Substitution of incorrect washers. (Too thin).
3. Washers reused. Each tightening of the connector screw successively makes each washer thinner and thinner until the screw ultimately bottoms.
4. Overtightening of connector screw (see torque valve chart)  
Seizure usually occurs immediately on rotating the pump after bottoming the connector screw.

Examination of the discharge ports will usually show that the bottomed connector screw left a shiny mark in the bottom of the port. A similar shiny mark appears on the bottom of the connector screw.

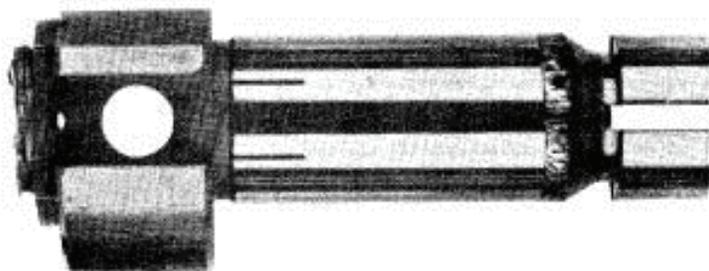
EXAMPLE III - HYDRAULIC OR MECHANICAL SIDE THRUST AT TRANSFER PUMP

LOCATION: TRANSFER PUMP END OF ROTOR

- CAUSE:
1. Operating pump or engine at excessive speeds causing the transfer pump pressure to exceed 130 PSI.
  2. Wrong pressure regulating parts (spring or sleeve).
  3. Stretching or shimming the pressure regulating spring.
  4. Step plug too long. (Service Bulletin #153A).
  5. Ice in transfer pump (blades usually smashed).
  6. Over-tightening of transfer pump rotor (A, D & E pumps) causing restriction of endwise movement of blades.
  7. Tight transfer pump blades.
  8. Broken transfer pump blades.

9. Stuck regulating piston (rust, dirt or burrs).
10. Overtightened end plate screws.

On test stands carefully observe transfer pump pressures on the initial run-up in pump speed.

On engines, when adjusting stop screws be careful not to allow the engine to greatly overspeed.

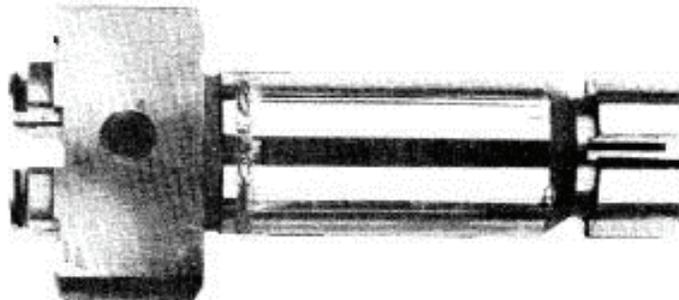
EXAMPLE IV - MECHANICAL SIDE THRUST OR MISALIGNED DRIVE

LOCATION: Plunger end of rotor

- CAUSE:
- A. Misalignment of pump to engine or test stand.
    1. Incorrectly designed, shop-made adaptors for test stand.
    2. Failure to use proper alignment bushings with test stand adaptors.
    3. Improper clearance of Oldham coupling on test stand or engine.
    4. Excessive end thrust on drive shaft due to improper thrust button and/or thrust button spring, or interference at engine end of drive shaft.
    5. Drive shaft 180° out of location when locating pin has not been removed. (Service Bulletin #79R1). Shaft off-set on vertical drives.
    6. Attempting to time injection pump when engine is operating.
    7. Burr or dirt on engine/pump mounting pad.
    8. Worn or improper drive shaft bushings in engine block. (Vertical pumps).
    9. Insufficient backlash in pump drive.
    10. Locating dowels for pump mounting bracket not used ("A" pumps).

- B. Misalignment of internal pump parts.
1. Improper assembly.
  2. Incorrect parts used.
  3. Broken internal pump parts (shoe, leaf spring, leaf spring screw, etc.) jammed between cam and rollers.

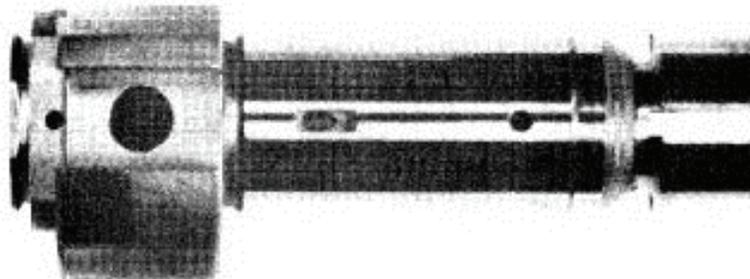
EXAMPLE V - OVERTIGHTENED DELIVERY VALVE STOP OR END PLATE SCREWS

LOCATION: Near transfer pump end of rotor.

CAUSE: Over-torquing of delivery valve stop screw or end plate screws. Tightening of this screw without a torque wrench can cause a swelling of the rotor at this point destroying the head and rotor clearance.

Use a new stop on reassembly of the delivery valve and its components. (Service Bulletin #157). Observe correct tightening torque (Service Bulletin #106R).

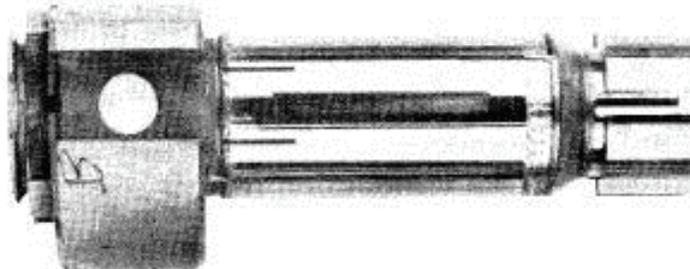
EXAMPLE VI - PLUGGED NOZZLE, INJECTION LINE OR HIGH PRESSURE FITTINGS

**LOCATION:** Either end or both ends of rotor (DB). Both ends of rotor (A, E & D)

**CAUSE:** Nozzle pipe or fittings plugged closed. This causes excessive line pressure during discharge. As a result the head bore becomes barrel shaped and causes seizures at either or both ends of the rotor.

This type of seizure may occur after any number of hours operation with the defective nozzle.

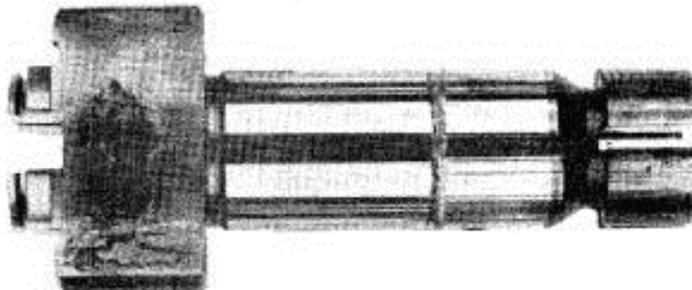
EXAMPLE VII - CONTAMINATED FUEL (Moisture)

**LOCATION:** Between charging and discharge ports in rotor. Look for rust, corrosion, stains or discoloration of the rotor also.

**CAUSE:** Contamination in the form of solutions used to clean fuel tanks, condensation in the tank and improper lay-up fuels are the main causes for this failure type.

**REMEDY:** Drain and flush tanks with clean diesel fuel, drain all supply and return lines, change all filters. Keep tanks filled overnight to preclude condensation formation during abrupt temperature changes. Consult your engine manual or the manufacturer for information on approved additives.
