ATTENTION!!

Before and After pics of the Injector seal due to oil pressure manifold O ring failure.

6.0L High Pressure Oil Rail

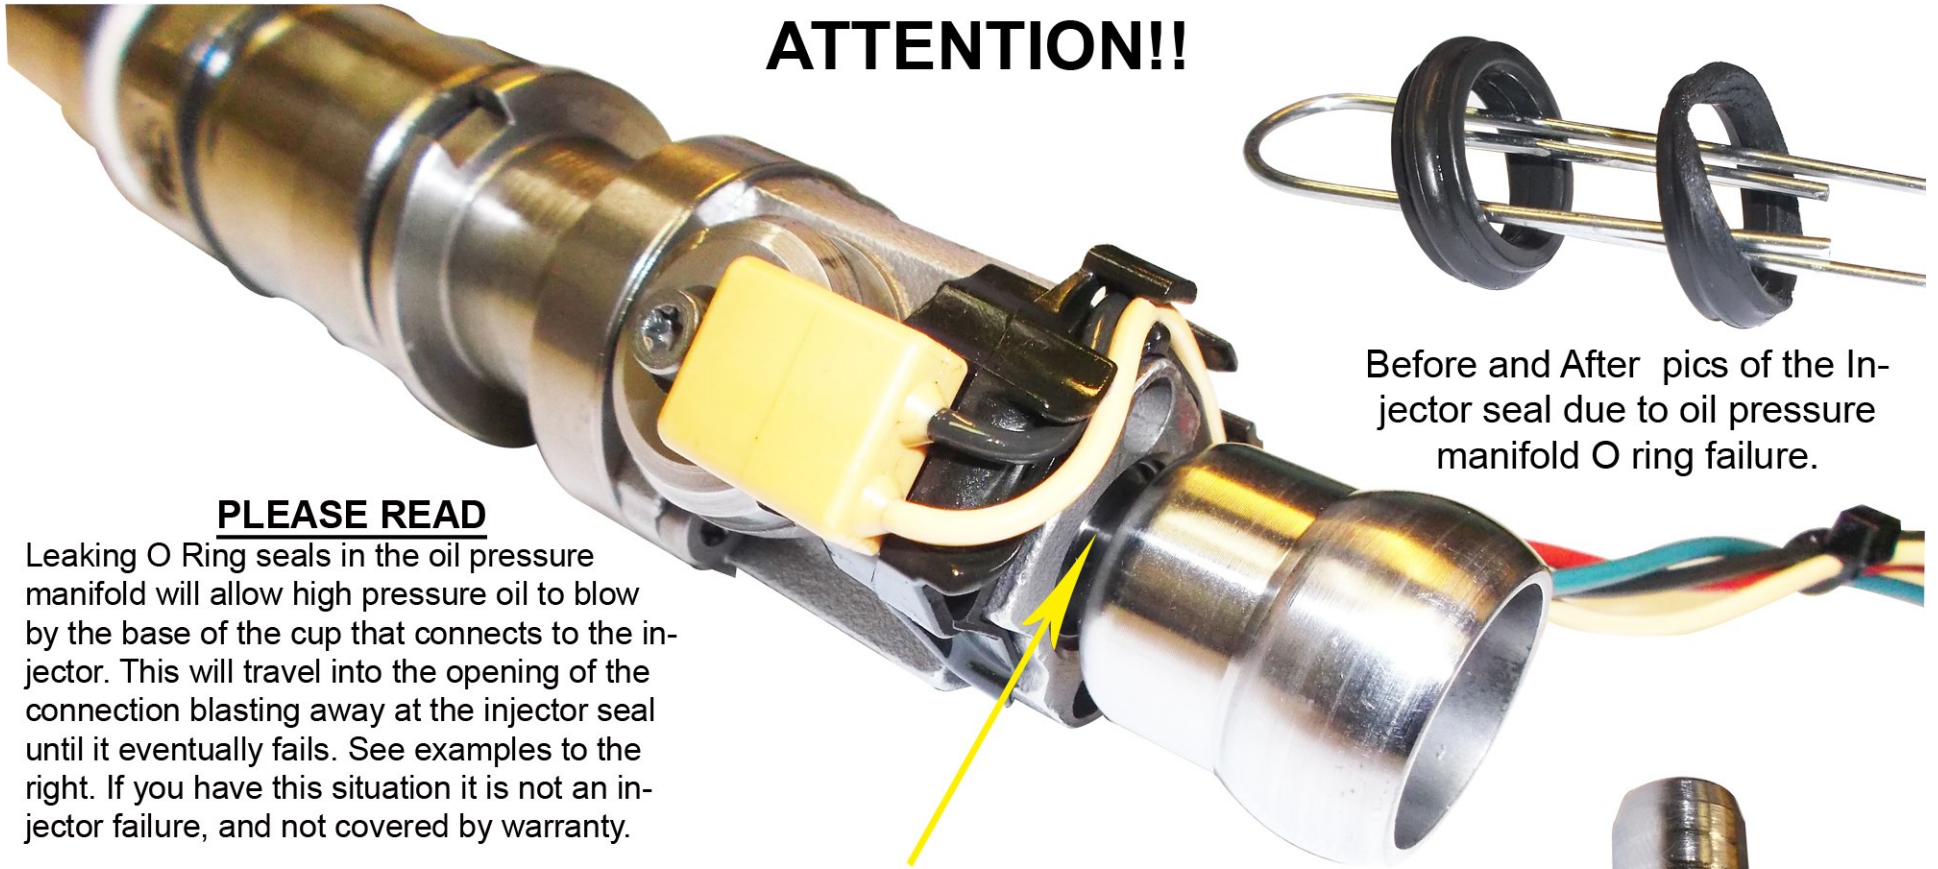
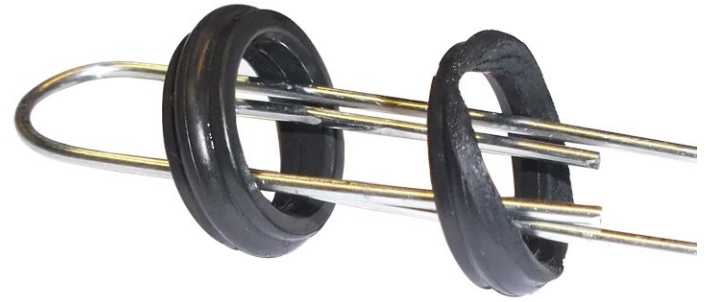
Leaking O Ring seals in the oil pressure manifold will allow high pressure oil to blow by the base of the cup that connects to the injector. This will travel into the opening of the connection blasting away at the injector seal until it eventually fails. See examples to the right. If you have this situation it is not an injector failure, and not covered by warranty.

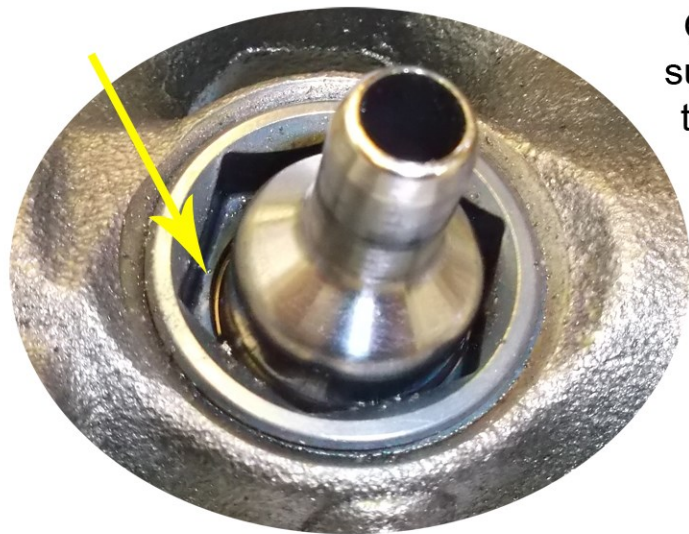
Oil travels along the outside surface of the cup and attacks the injector seal through this opening

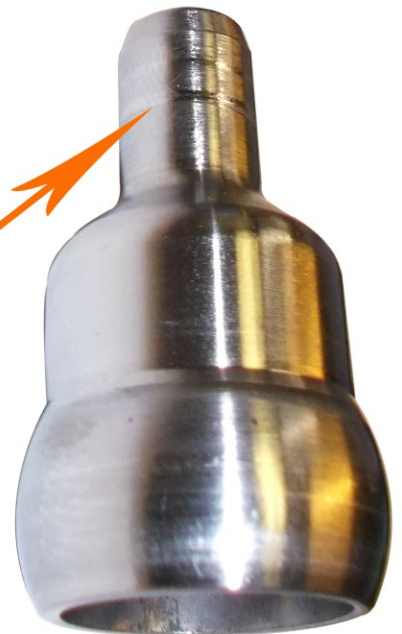
Note Damage pattern on the end of cup where it seals with injector from being blasted with external high pressure oil from the oil pressure manifold.

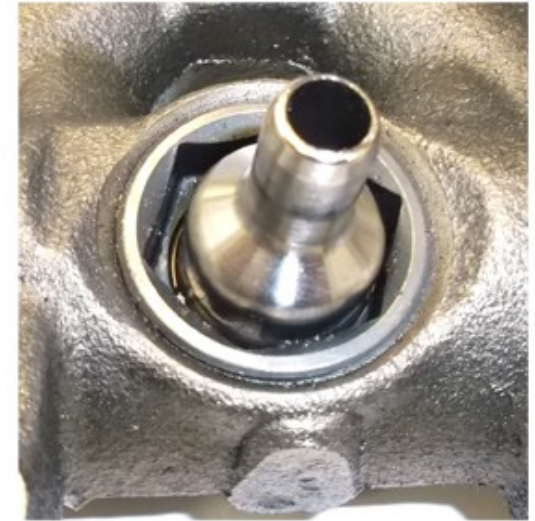
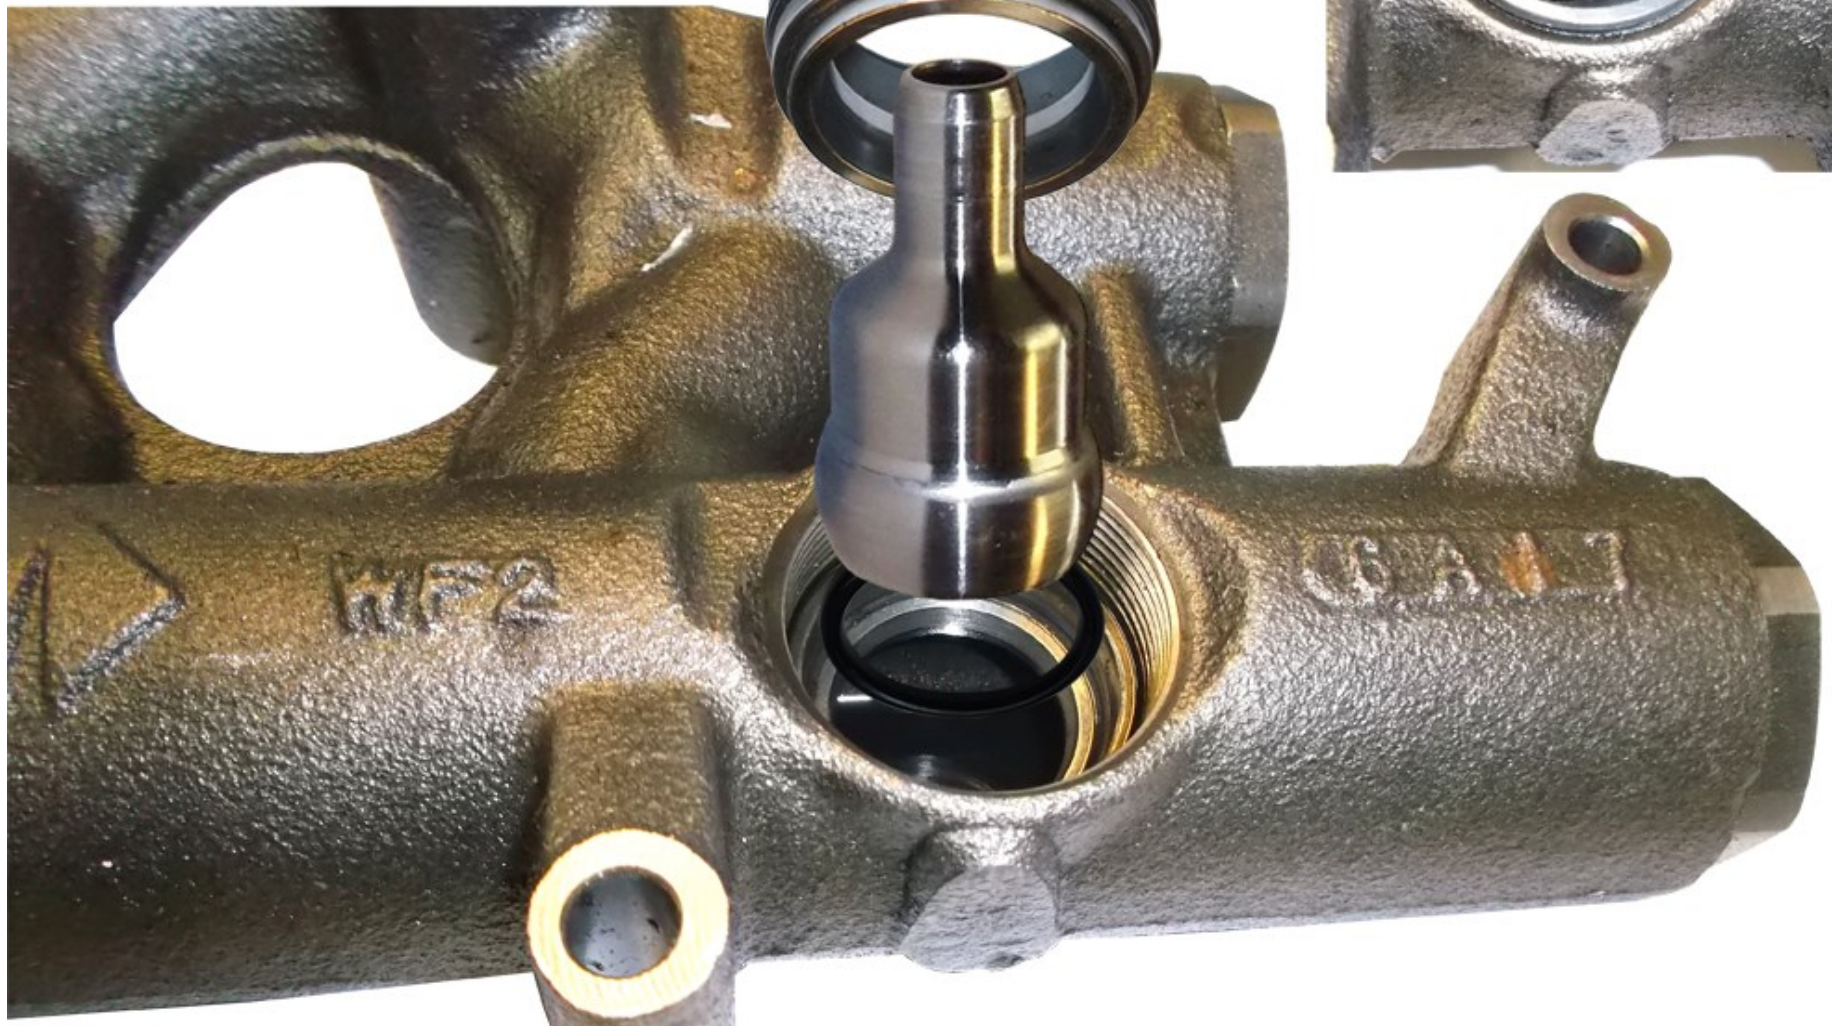
Assembled

Unassembled
